Infiltration Feasibility Evaluation

Gages Crossing Townhomes Development NWC of E. Gilkey Road & S. Anacortes Street Burlington, Washington

August 4, 2023
Project No. 22-0886

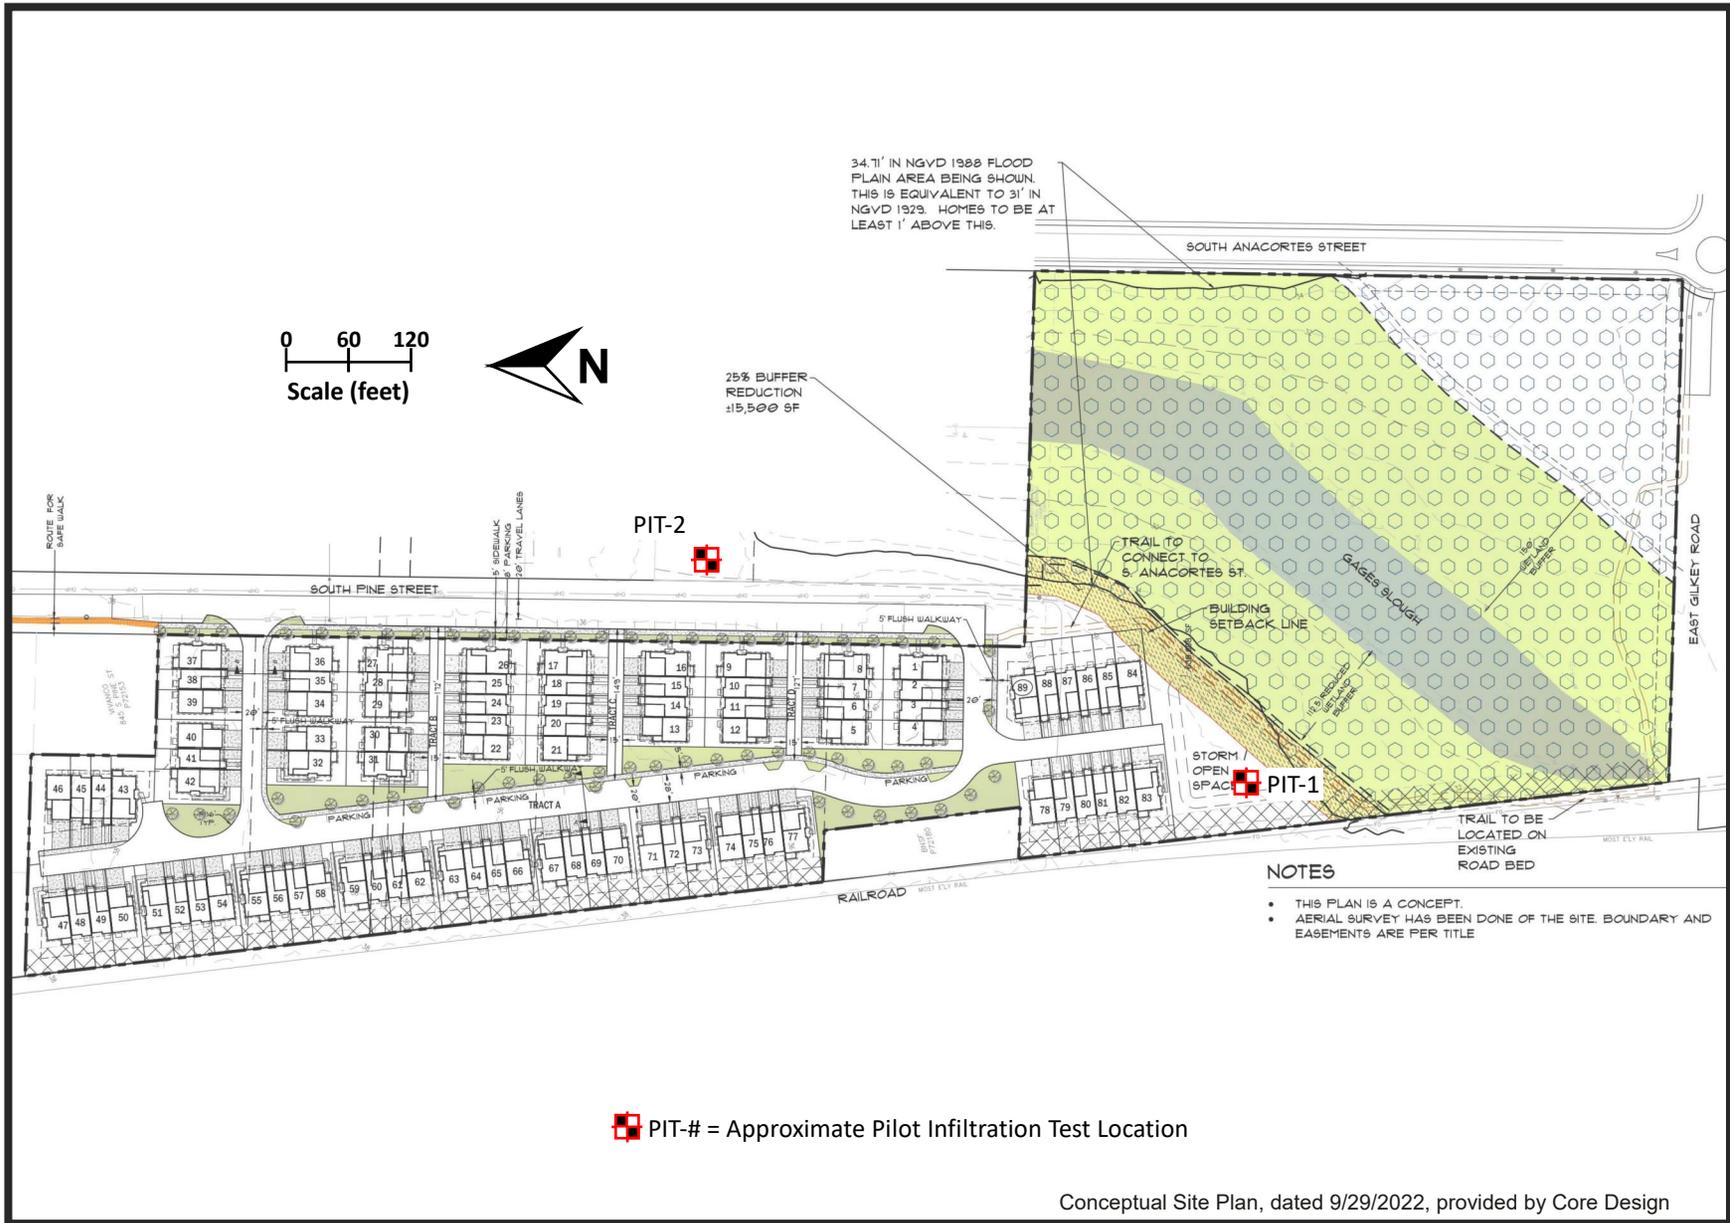
PIT-# = Approximate Pilot Infiltration Test Location

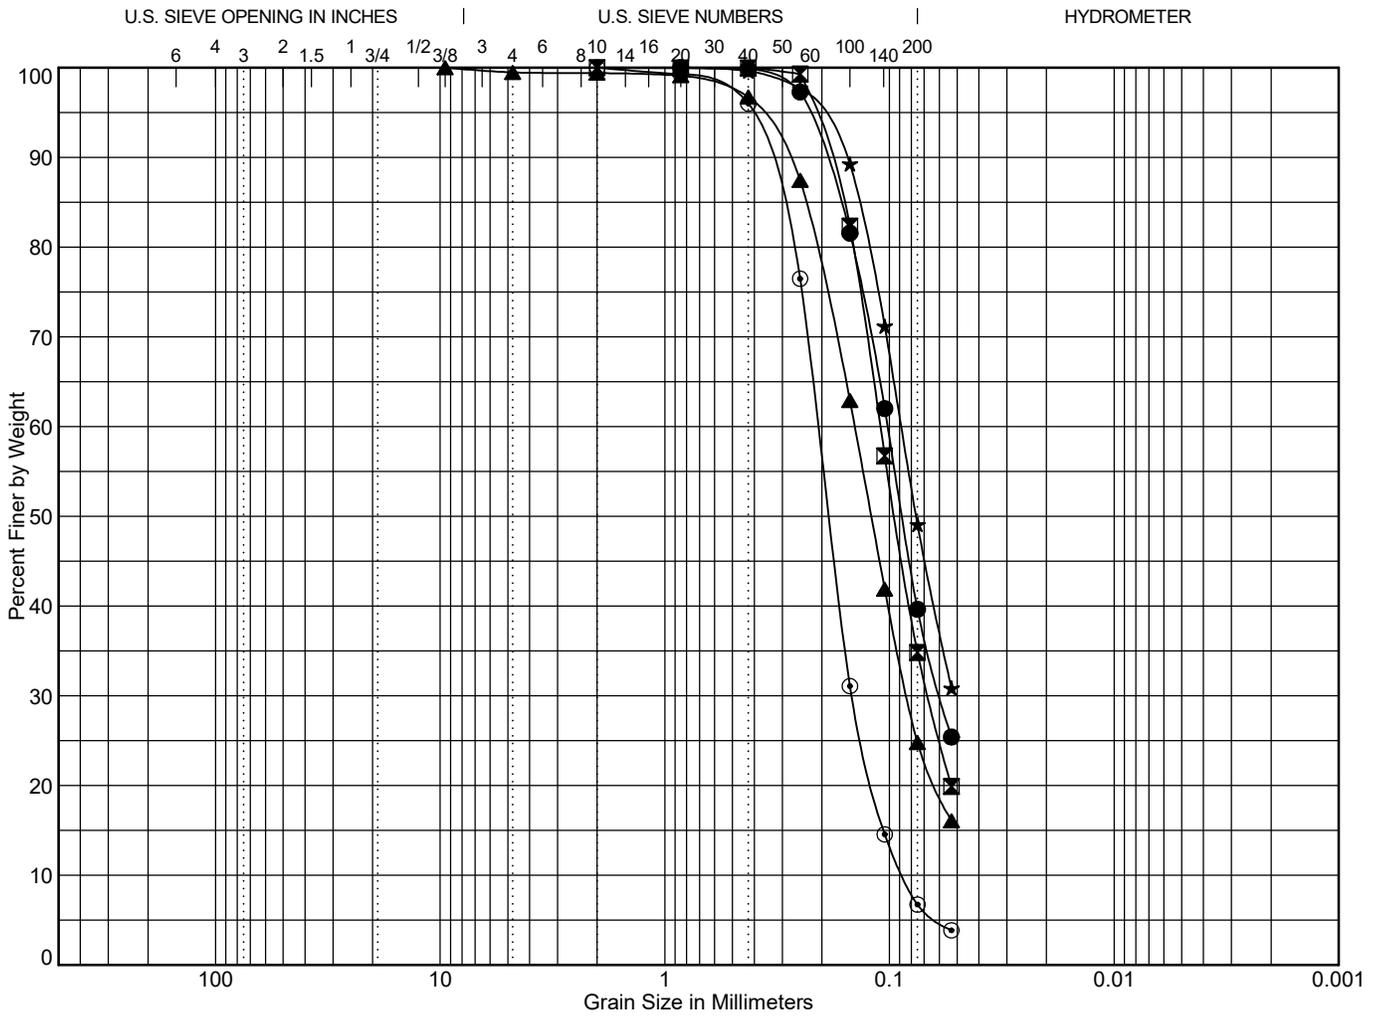
Cobbles	Gravel		Sand			Silt or Clay
	coarse	fine	coarse	medium	fine

Point	Depth	Classification	LL	PL	PI	C _c	C _u
●	PIT-1 5.0	Very silty SAND (SM)					
☒	PIT-1 8.0	Very silty SAND (SM)					
▲	PIT-2 4.2	Silty SAND (SM)					
★	PIT-2 7.0	Very silty SAND (SM)					
◎	PIT-2 8.9	Slightly silty SAND (SP-SM)				1.20	2.41

A GeoTest Geotechnical Technician directed and observed excavation operations and logged the soils encountered for the PIT explorations. Representative grab samples were generally obtained at approximately 2-foot intervals, at the base of the PIT location, and upon encountering new soil characteristics. Soils were classified in general accordance with the guidelines of the American Society for Testing and Materials (ASTM) D2487 and D2488. Upon completion, each PIT location was backfilled to existing grades with the excavation spoils and bucket tamped. Please refer to the attached *Site and Exploration Plan*, Figure 2, for approximate PIT locations. A *Soil Classification System and Key* is found on Figure 3. Detailed PIT exploration logs are attached as Figures 4 and 5 – *Test Pit Logs*, with laboratory analysis presented as Figure 6.

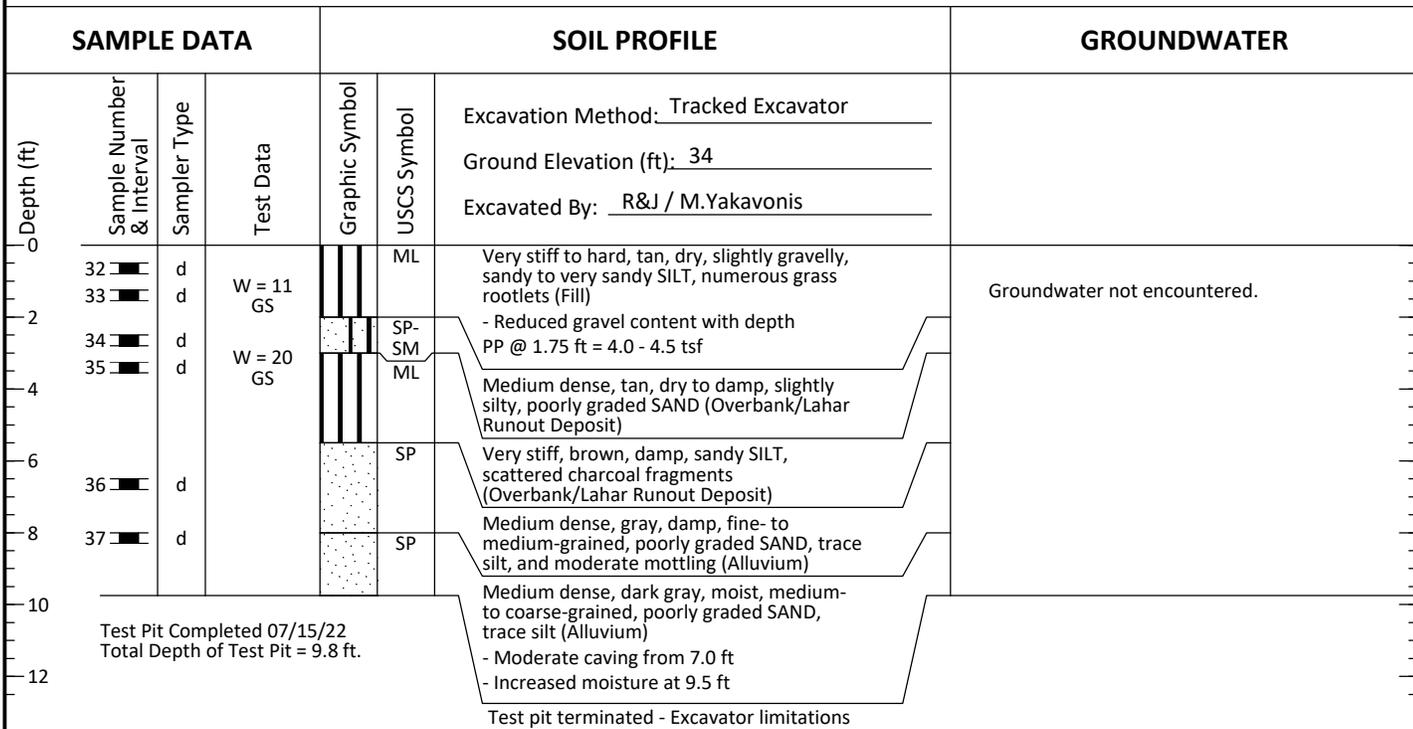
TP-7

Ground elevations are estimated from the provided Conceptual Site Plan, dated 5/24/22, for all test pit logs.

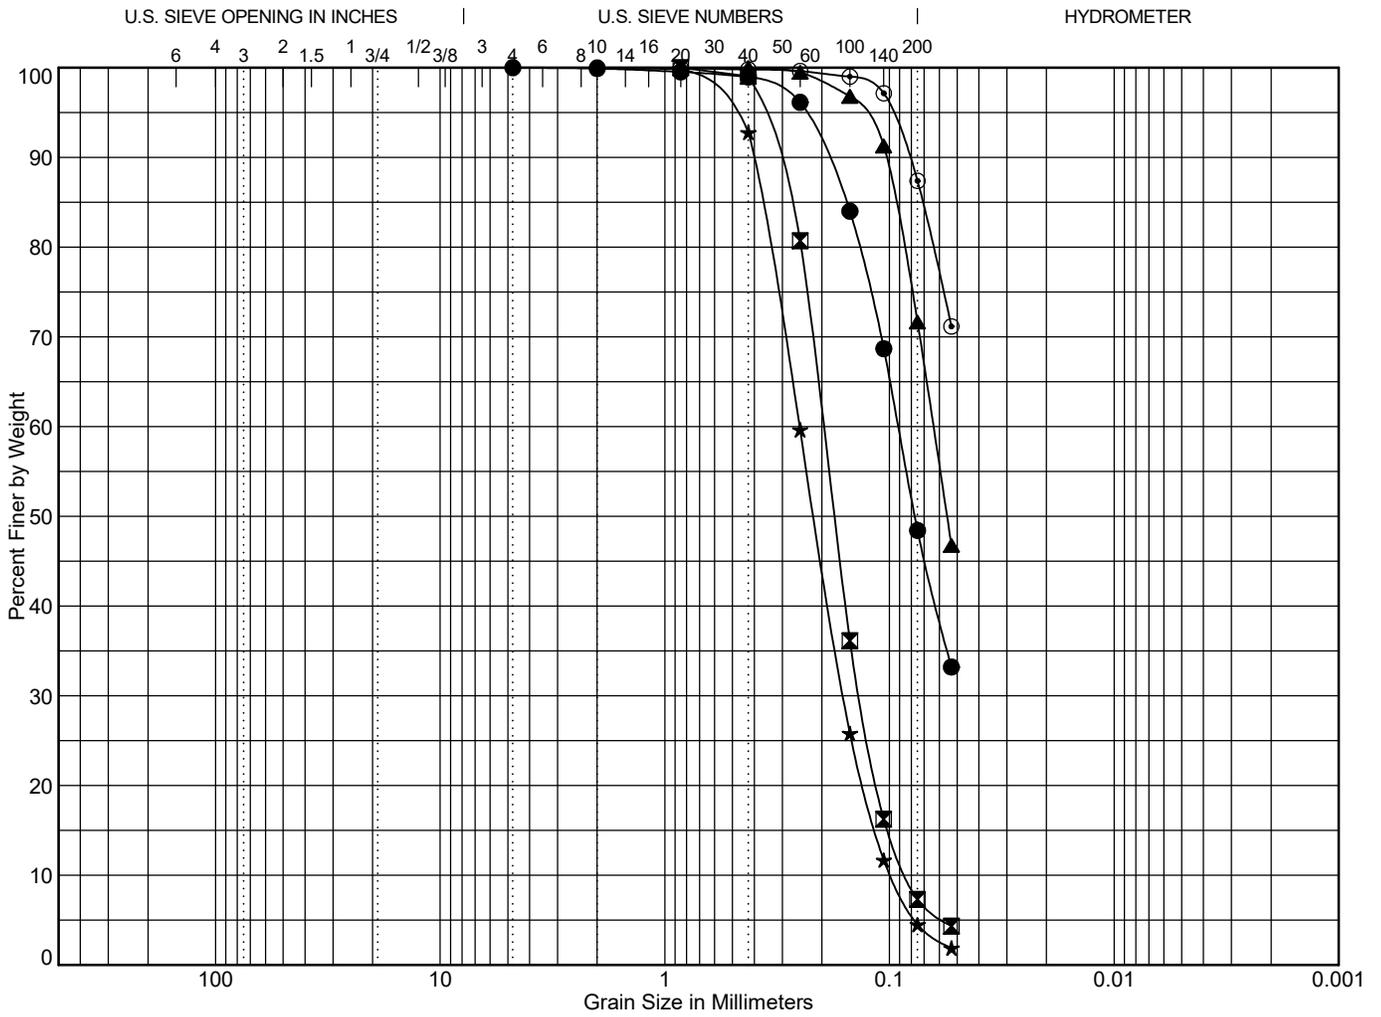
Figure
 8

Cobbles	Gravel		Sand			Silt or Clay
	coarse	fine	coarse	medium	fine

Point	Depth	Classification	LL	PL	PI	C _c	C _u
●	TP-1 1.3	Very silty SAND (SM)					
☒	TP-2 1.8	Slightly silty, poorly graded SAND (SP-SM)				1.11	2.37
▲	TP-2 2.8	Sandy SILT (ML)					
★	TP-2 6.0	Poorly graded SAND, trace silt (SP)				1.04	2.57
⊙	TP-4 1.5	Sandy SILT (ML)

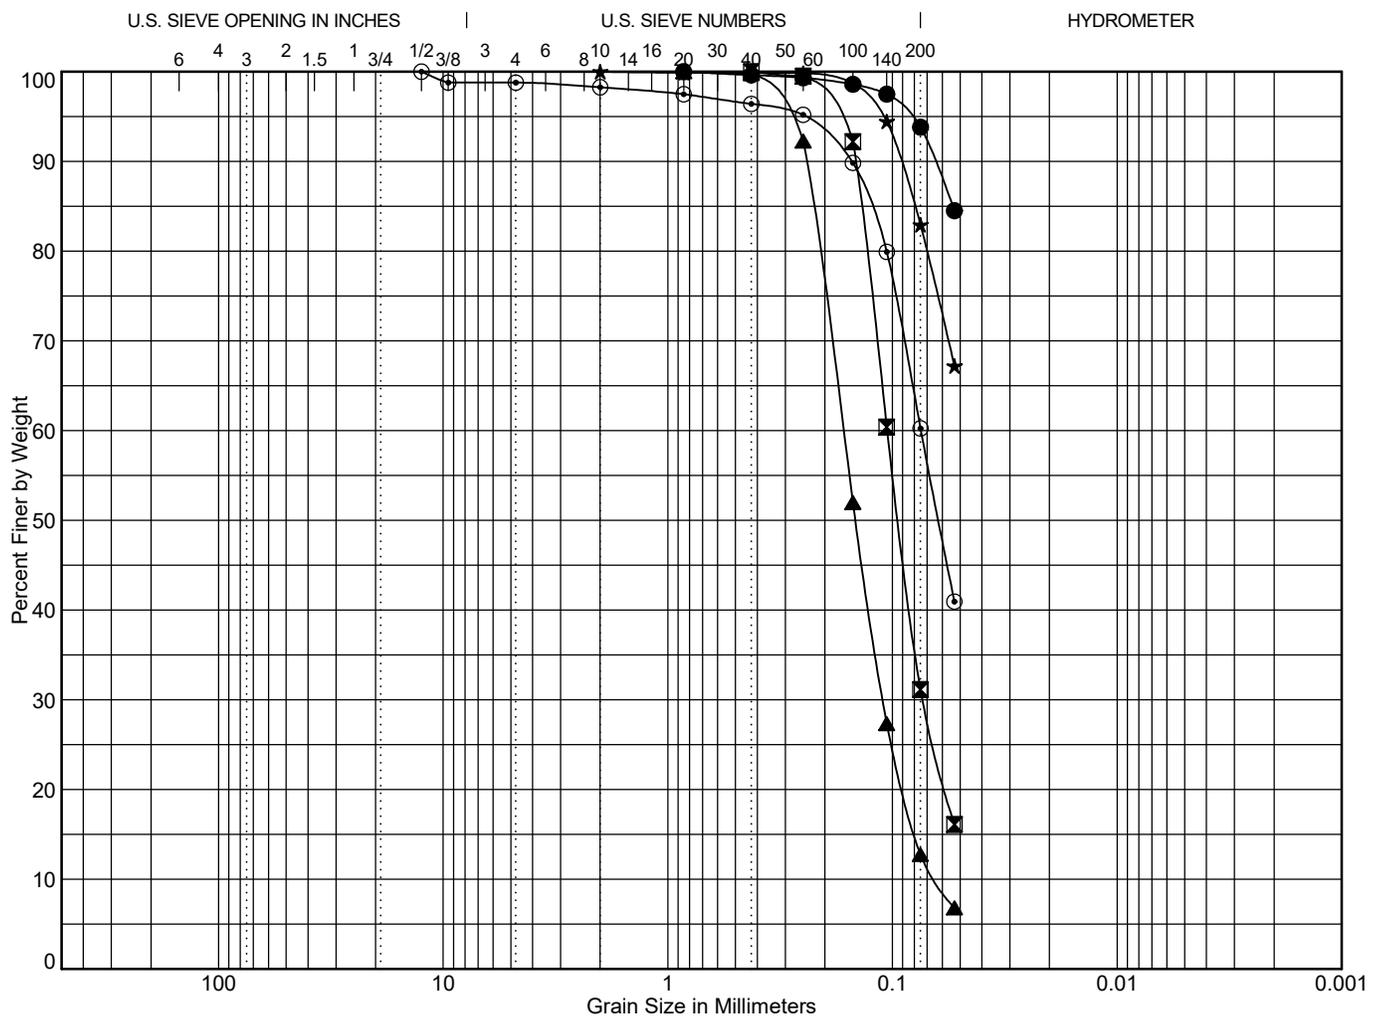
Figure
 9

Cobbles	Gravel		Sand			Silt or Clay
	coarse	fine	coarse	medium	fine

Point	Depth	Classification	LL	PL	PI	C _c	C _u
●	TP-5 3.5	Slightly sandy SILT (ML)					
☒	TP-5 6.0	Very silty SAND (SM)					
▲	TP-6 1.3	Silty SAND (SM)				1.14	2.60
★	TP-6 3.5	Sandy SILT (ML)					
◎	TP-7 1.3	Very sandy SILT, trace gravel (ML)

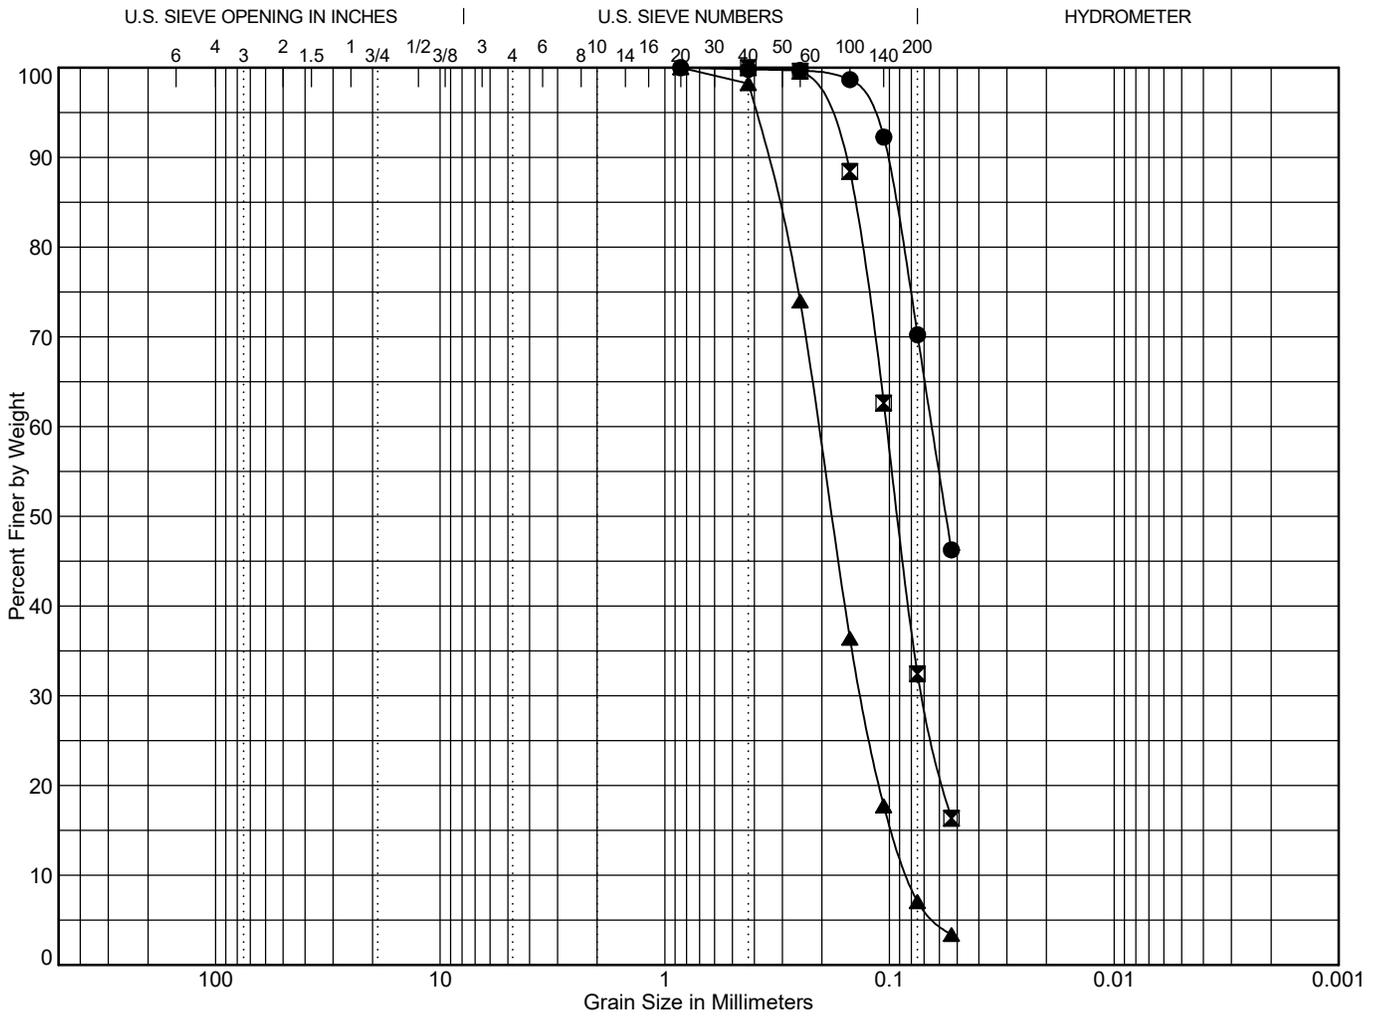
Cobbles	Gravel		Sand			Silt or Clay
	coarse	fine	coarse	medium	fine

Point	Depth	Classification	LL	PL	PI	C _c	C _u
●	TP-7 3.3	Sandy SILT (ML)					
☒	TP-8 4.0	Very silty SAND (SM)					
▲	TP-8 6.0	Slightly silty, poorly graded SAND (SP-SM)				1.04	2.51
